## Mitigation of Lateral Buckling at an In-line Tee

Ludovic Assier, Cédric Lerche and Hervé Gueveneux - Total EP

Leanne Tindall, Lee Martin, Ian MacRae and David Bruton - Crondall Energy

### 1. Abstract

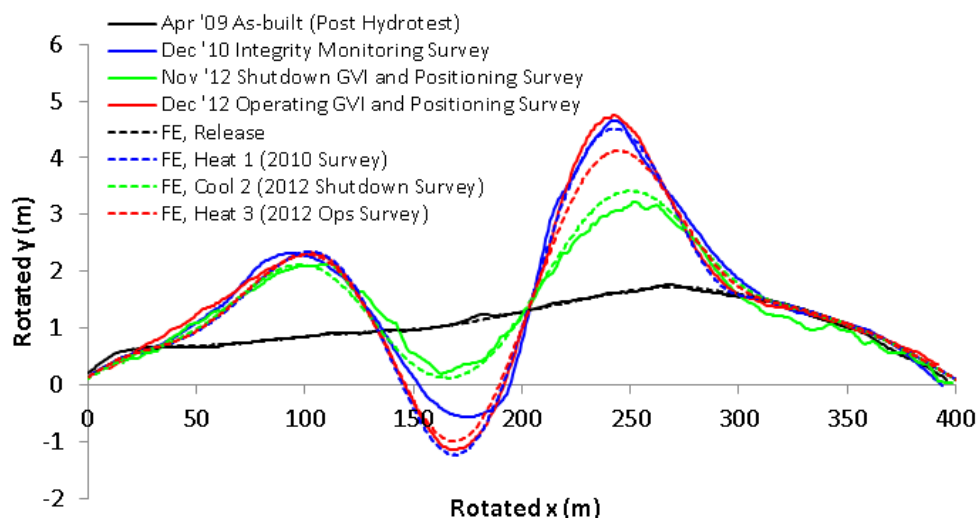
Figure 4 shows a comparison of the survey data (solid lines) and the results of the best fit FE analysis (dashed lines). There are some small differences between the as-built OOS data and the smoothed FE analysis due to minor fluctuations in the survey data, which was of exceptional quality. The results from the FE analysis match well with each set of survey data, although there are slight differences in the peak displacement at the two main lobes of the buckle, which do not influence the overall response.

**Figure 4 – Comparison of lateral shape**

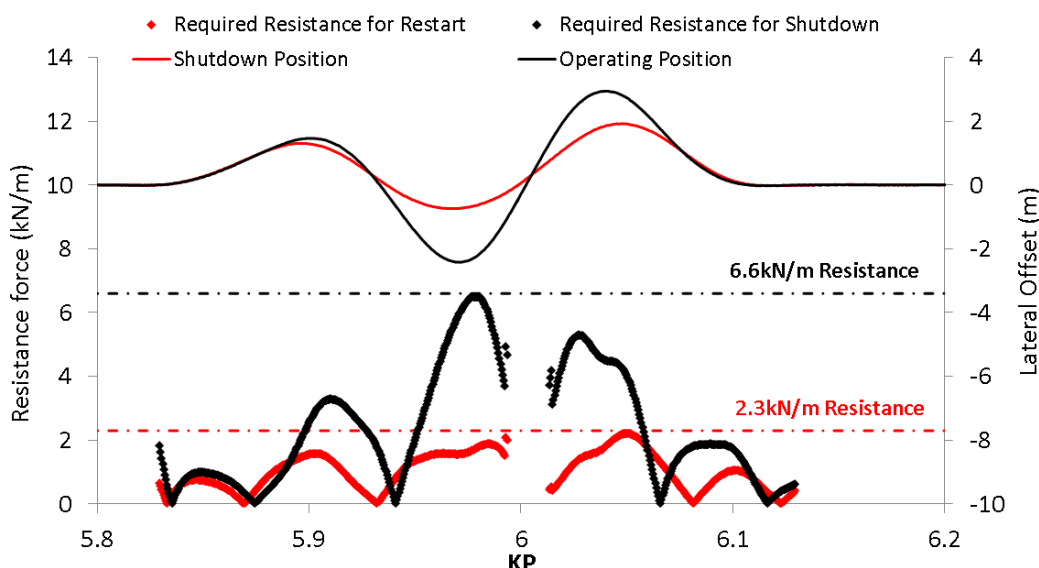
Figure 5 shows the restraint required, with the pipe in the shutdown and operating conditions, to prevent movement on the following loading condition (either operation or shutdown). The results show some end effects (load spikes) at the ends of the modelled restraint. This could indicate that the coverage may be insufficient. However, the modelling here allows no movement under cyclic loading. In practice, small movements would be acceptable.

The results indicate that significantly higher restraint is required to prevent the buckle moving when the mitigation is applied in operation, because the buckle amplitude is larger; i.e. 6.6kN/m is required when the restraint is applied in operation, compared to 2.3kN/m required when the restraint is applied with the pipe shutdown.

**Figure 5 – Restraint mitigation**

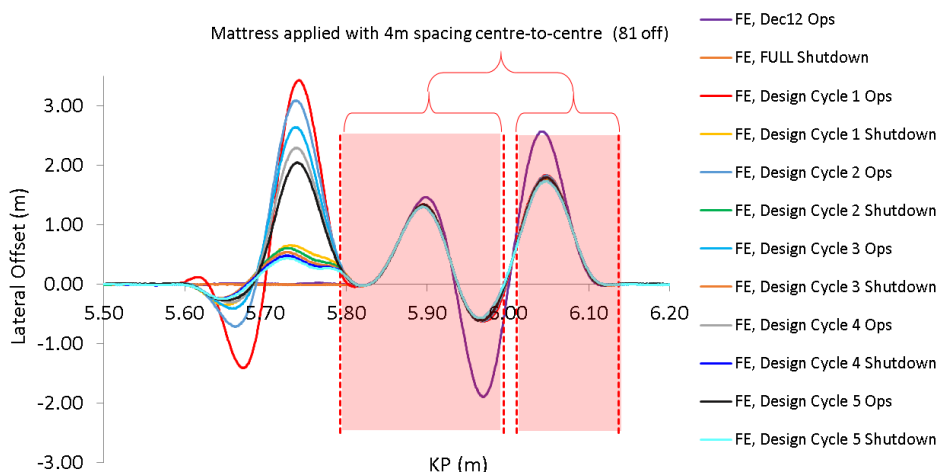
The initial restraint assessment identifies a peak restraint loading of 2.3kN/m is required to restrain movement at the ITA. A model was developed with discontinuous restraint applied across the buckle (4m spacing of mattresses), with an average lateral resistance of 2.3kN/m. The displaced shape from the assessment is shown in Figure 8.

**Figure 8 – Displaced shape, discontinuous restraint**

The results show that the buckle is well restrained as a result of the mattresses; however, during the first heat up, post mattress installation, an additional buckle forms at the edge of the matted region. The buckle forms as a result of the increased axial force associated with the bank of mattresses, in combination with an out-of-straightness feature at around KP5.7. The formation of the buckle does not pose an integrity threat to the pipeline or ITA, however, its proximity to the ITA is undesirable.

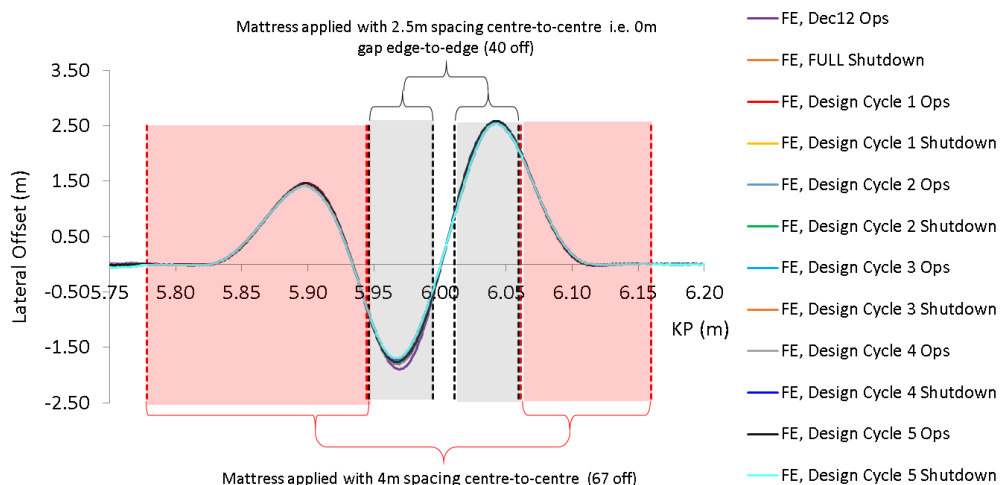
**Figure 10 – Displaced shape, mix of continuous and discontinuous restraint**

The figure presents the displaced shape of the pipe throughout, and shows that cyclic movement of the buckle arrests following mattress placement. However, smaller levels of displacement are indicated at the crown of the central lobe; KP5.97. Although small movements are indicated, they do not appear to cause significant rotation at the ITA. The results presented in Figure 11 show a maximum rotation of  $\sim 0.5^\circ$  during each start-up shutdown cycle.

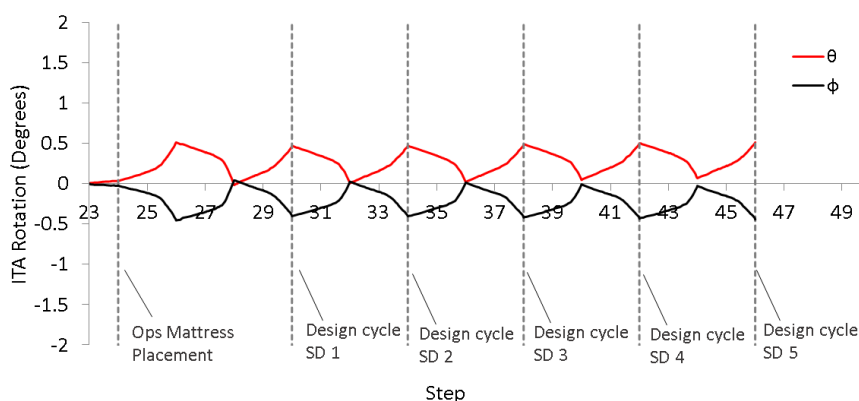
**Figure 11 – Rotation, mix of continuous and discontinuous restraint**

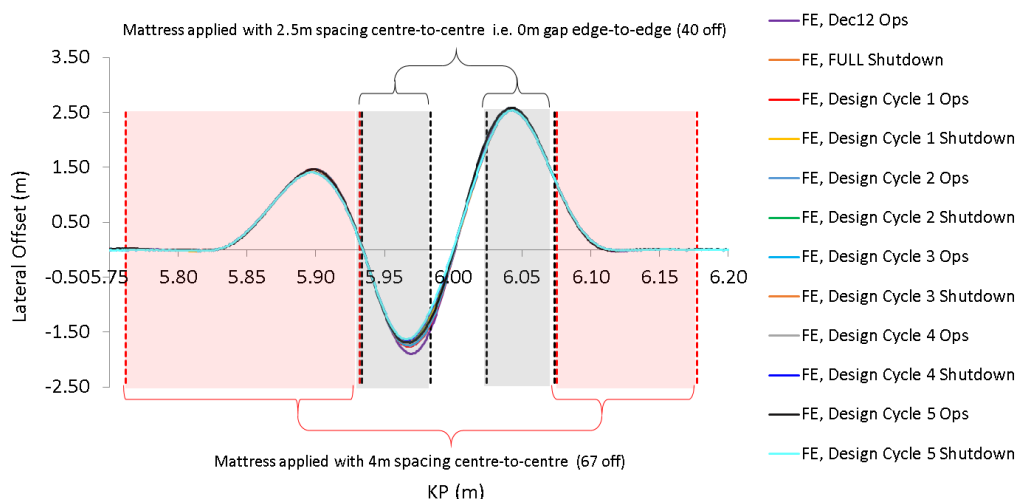
The proposed mattress configuration was modelled. Figure 13 shows the displaced shape from the assessment.

**Figure 13 – Displaced shape, proposed mattress configuration**

The results indicate that the buckle is well restrained despite the larger gap at the ITA. The rotation at the ITA is compared in Figure 14 for the original case, and the case with the increased gap at the ITA. The rotation is larger as a result of the increased gap, but this increase is small and the rotations remain acceptable.

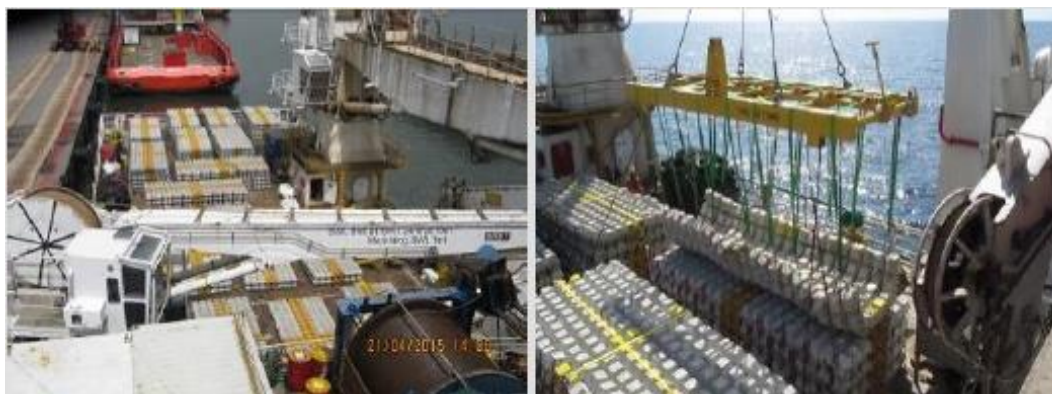
80 of the 107 mattresses were loaded on the Operation, Inspection, Maintenance and Repair Vessel (OIMR Vessel) deck, the remaining being sent offshore by supply vessel (Figure 16).

**Figure 16 – OIMR Vessel deck arrangement**

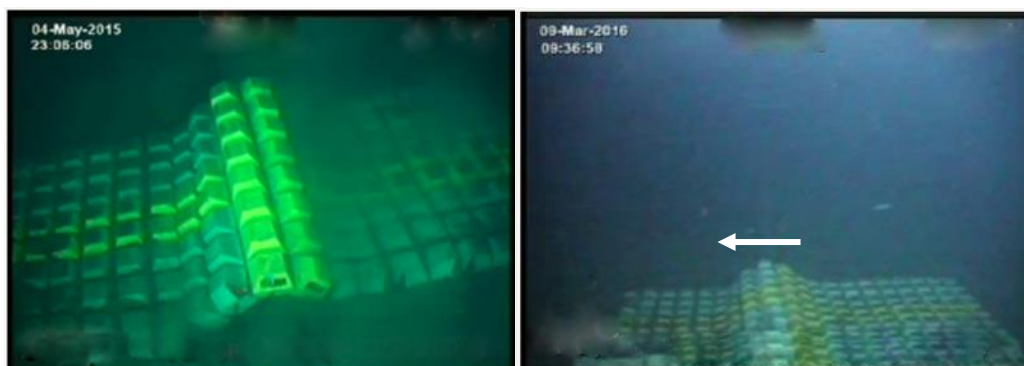
Images from surveys are presented in Figure 19 to the South of the ITA and Figure 20 to the North of the ITA. The images on the left were taken when the mattresses were installed in the operating condition in 2015; the images on the right were taken from the survey conducted with the pipeline in the shutdown condition on 9<sup>th</sup> March 2016. The images show how the pipe has moved underneath the mattresses.

**Figure 19 – South side of ITA – at installation and after shutdown**

The pipe at the South side of the ITA (Figure 19) appears to have moved laterally by about two blocks (~0.6m). The pipe at the North side of the ITA (Figure 20)

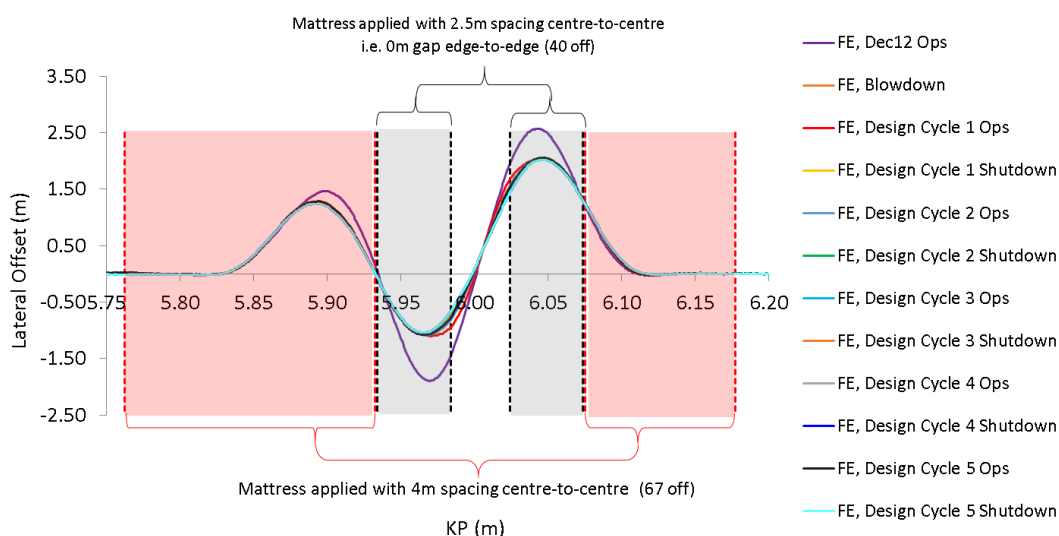
Further FE analysis has been completed to replicate the rotation measurements by reducing the lateral restraint provided by the mattresses on first load before the full weight is mobilised (Figure 21).

**Figure 21 – Displaced shapes, response tuned to match observations**

The buckle shapes from the model are shown in Figure 21. The buckle shape shows a displacement of less than 1m at each of the two main buckle lobes; this is consistent with the observed movements of the pipe underneath the mattresses. The results also indicate that the buckle shape stabilises with future cycles as the full mattress resistance is mobilised.
